Golf Course Management Magazine  
www.gcsaa.org • July 2015

## A change for the better

Southern California courses are finding that improved irrigation distribution uniformity can play a vital role in continued success in the midst of historic drought.

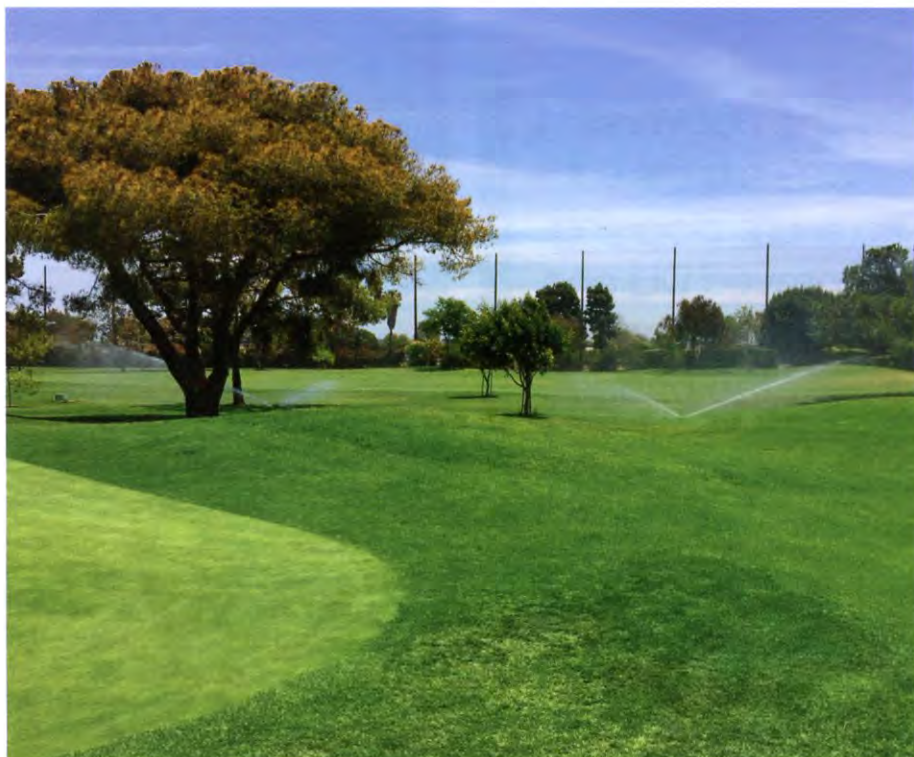
Replacing nozzles at both Costa Mesa (Calif.) CC and Strawberry Farms GC in Irvine, Calif., has improved distribution uniformity and saved money, according to superintendent Jim Fetterly.

"We were skeptical, but actually saw changes very quickly," he says. "These nozzles are made with solid brass and have stainless steel outlets. Nothing clogs them. The DU improved right away and eliminated

Ultimately, Fetterly switched out more than 700 nozzles in one year, a move that yielded even more good news. Strawberry Farms qualified for a nozzle rebate from the local water district in Orange County. The conversion was a triple win: no more clogging, improved DU and a little extra cash in the budget.

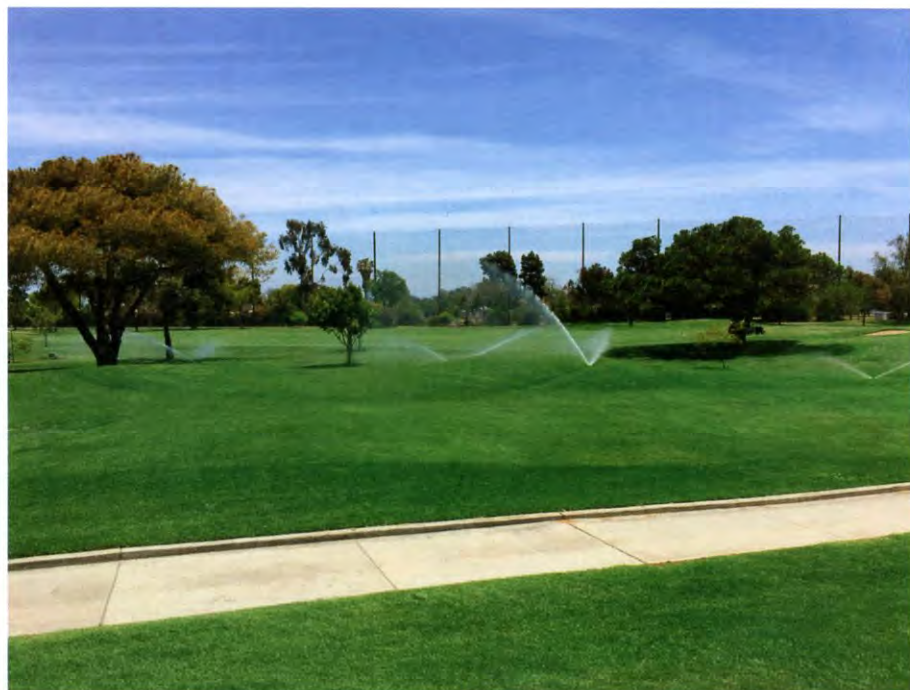
**Top:** More than 2,750 nozzles were replaced at the 36-hole Costa Mesa CC.

Based on his success at Strawberry Farms, Fetterly persuaded Costa Mesa to invest in a major switch-out of the aging OEM nozzles. Since the beginning of this year, he has changed more than 2,750 heads at the 36-hole property.

"We saw a difference in DU within days, because the water was applied evenly. Donuts and dry patches disappeared. Muddy areas, where we were overwatering, cleared up. And we could actually cut back on scheduling."
