Golf Course Management Magazine
www.gcsaa.org • June 2014

Weathering long-term drought with improved irrigation

Converting to solid metal nozzles improves distribution uniformity and reduces costs at a top Texas course.

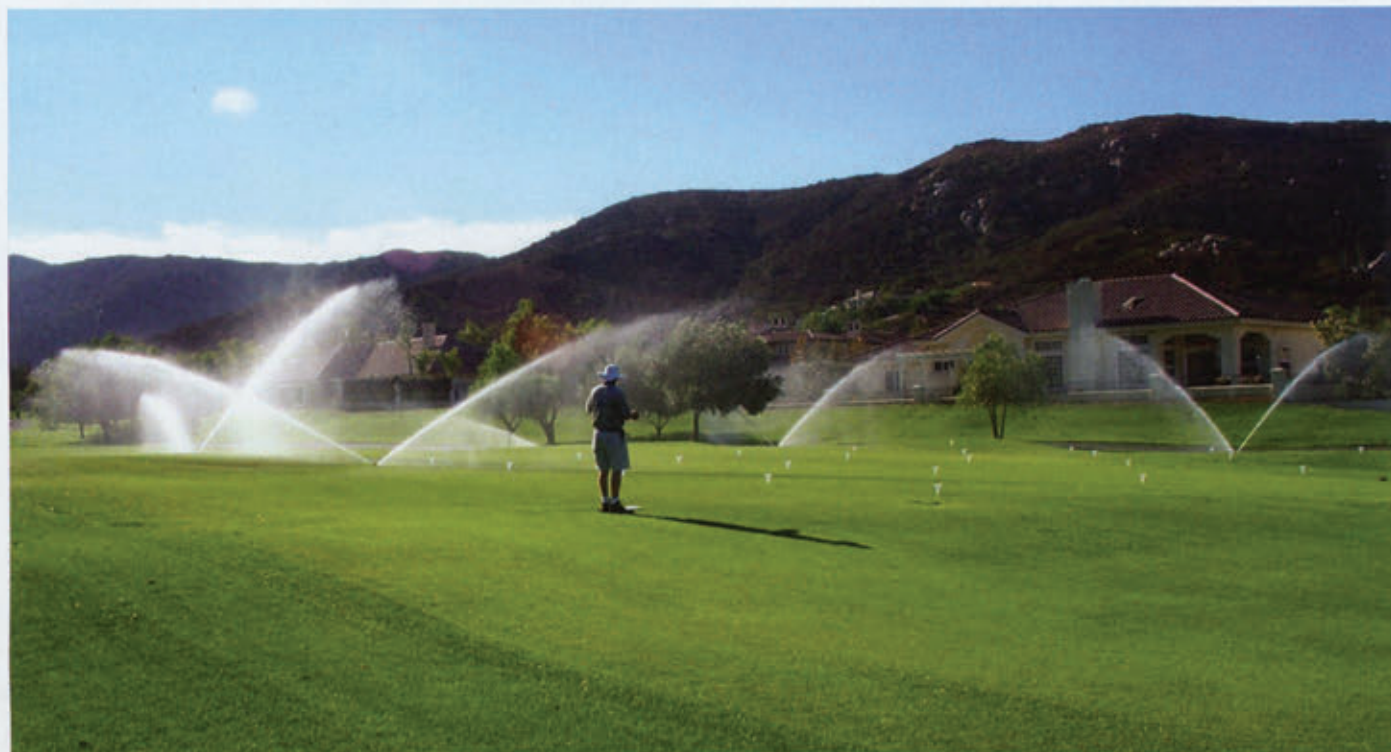
A catch-can test measures irrigation distribution uniformity in the field. Photos courtesy of Underhill

He notes that the best way to fully evaluate an irrigation system's distribution uniformity is either an on-site audit or a laboratory evaluation at the Center for Irrigation Technology. Using catch-can tests, overall distribution uniformity can be measured in the field, while in the lab accurate data can be collected and transcribed into a "profile" that can be used with software that projects performance when overlapped. The profile represents the shape of applied water along the length of a single sprinkler's throw. It is visually displayed as a sloping wedge.

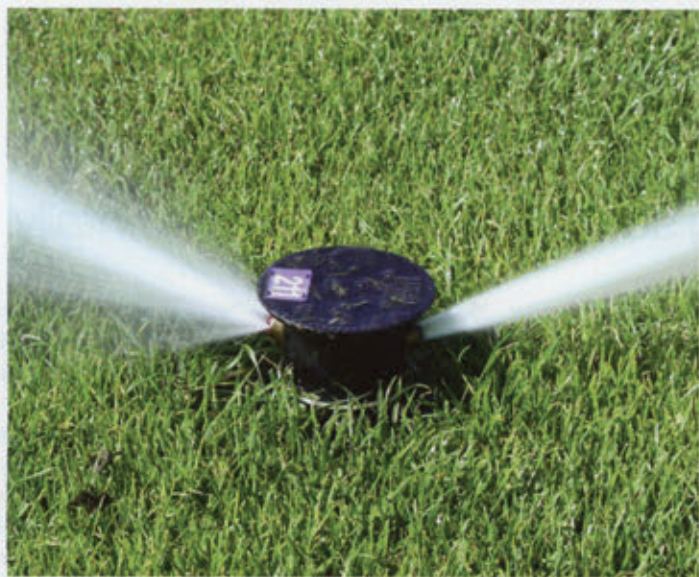
At Cordillera Ranch, retrofitting full-circle heads on the fairways with efficient solid metal nozzles cost around \$6,000.

"The ... retrofit cost approximately \$6,000. Our other option was to replace all the full-circle heads at a cost well over \$30,000. Dollar for dollar, the solid metal nozzles were one of the best investments we ever made. (They) paid for themselves in water, energy and labor savings."
